# How Much Land Has Been Lost?

Modified from OEAGLS EP-6, "Erosion along the Great Lakes," by Beth A. Kennedy, Newark Public Schools, Ohio, and Victor J. Mayer, The Ohio State University.

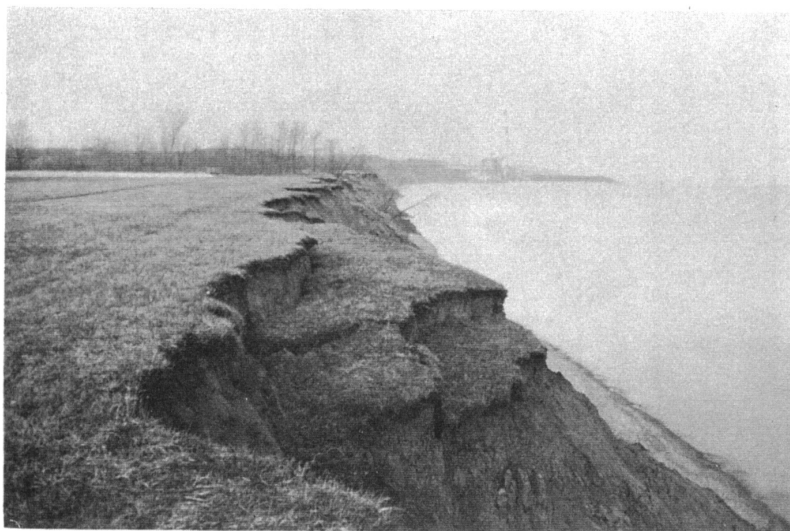
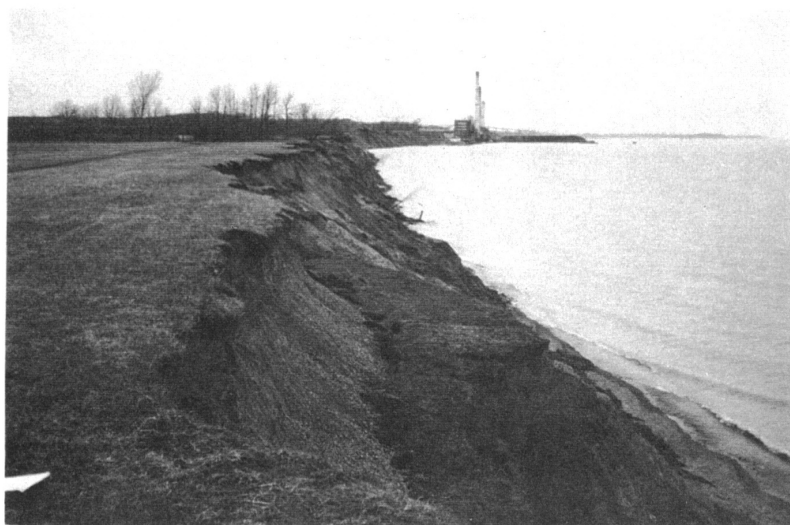
Site 2D-North

*Site 2D – North: "Note the large slump that is broken into three major pieces in photo 12/3/81. . . Photo 4/1/82 shows the remains of the slump failure. It is evident that the supporting soil of the slump block partially disintegrated, resulting in the downward movement of the slump. Also note the development of bluff overhang above the slump in photo 4/1/82. This overhang is not significant in photo 12/03/81. The remaining loose soil material above the slump is a remnant of the supporting soil structure before crumbling away, resulting in bluff overhang. . . (T)he scalloped shaped bluff edge in photo 12/3/81 is becoming more bowl-shaped in photo 4/1/82. Several slump events ranging from 4 feet by 2 feet to 75 feet by 10 feet have been observed at this location. In general, the bluff slope shown in photo 4/1/82 is becoming steeper." (Racine County Coast Watch Program Final Report, 1982, p. 85)*

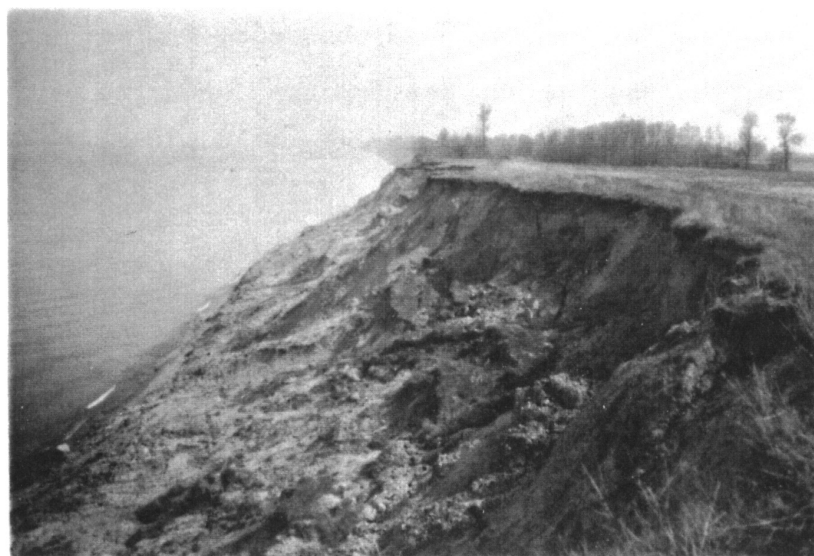
Site 1C-South 8/1/80

*Site 1C – South: "Photo 8/1/80 shows that the bluff edge was "scalloped" shaped and the bluff slope was steep. This site is subjected to wave attack that erodes the solid material from the bluff toe. . . . Photo 5/14/82 shows large slumps that detached from the bluff edge and slid down the bluff face. Recorded observations indicated that slump pieces vary greatly in size and range from 1 x 1 foot to 50+ feet long and 12 feet wide. The bluff edge has changed from the scalloped shaped to a bowl-shaped retreat. . . . The major slumps occurred over a 4-month time period in 1982." (Racine County Coast Watch Program Final Report, 1982, p. 83)*

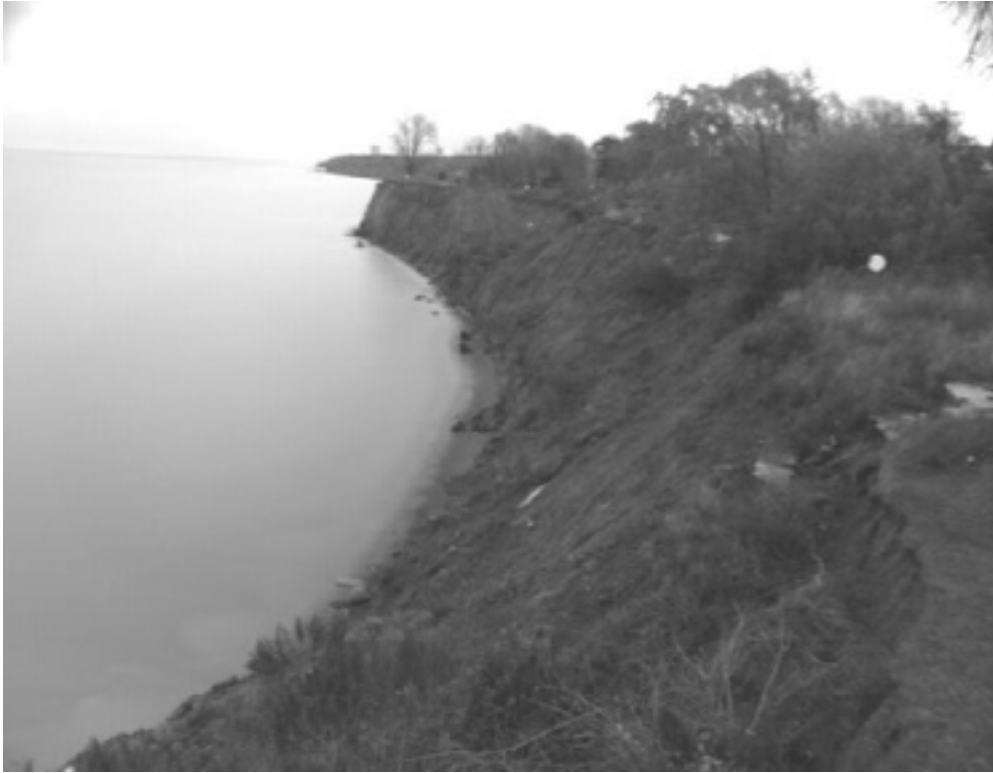
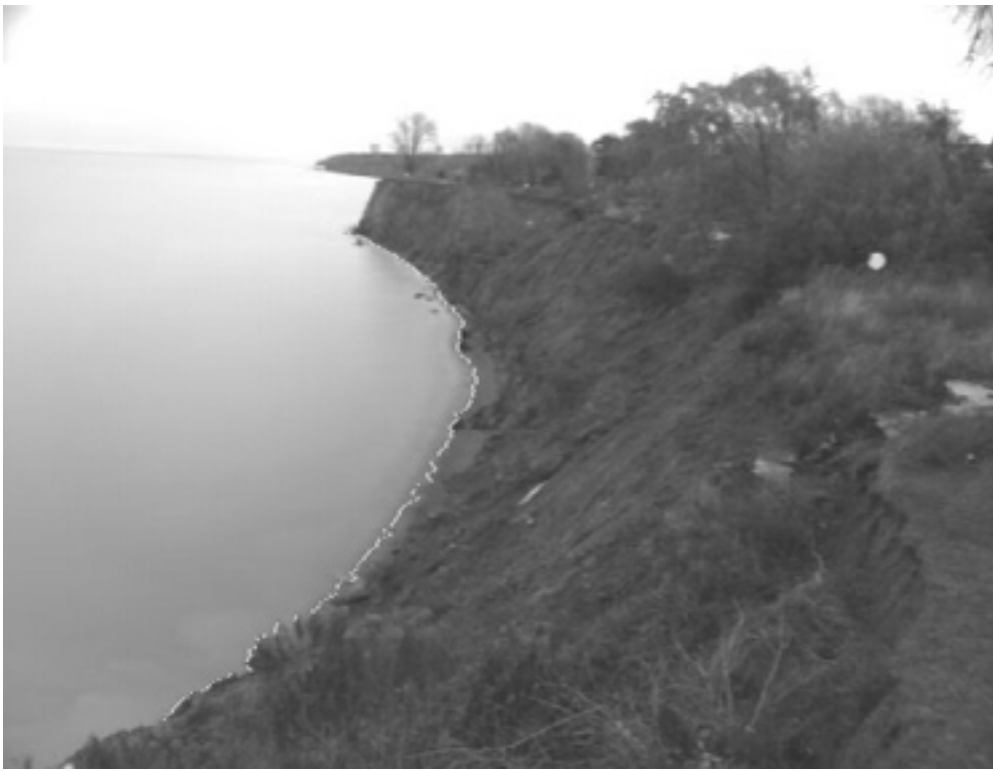
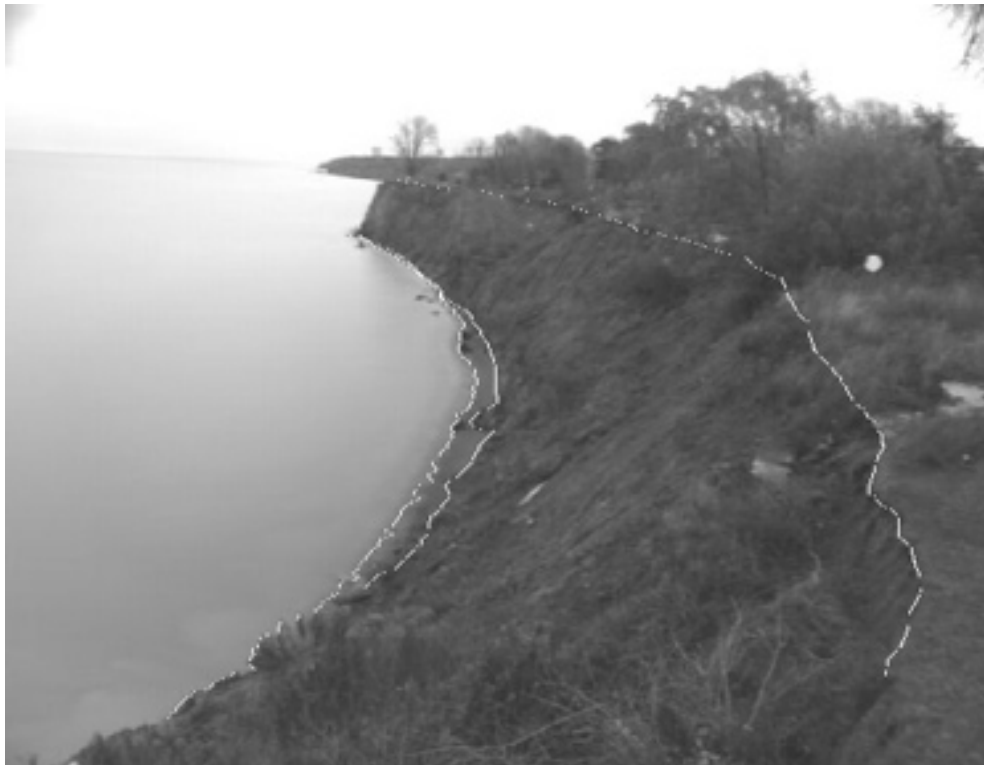
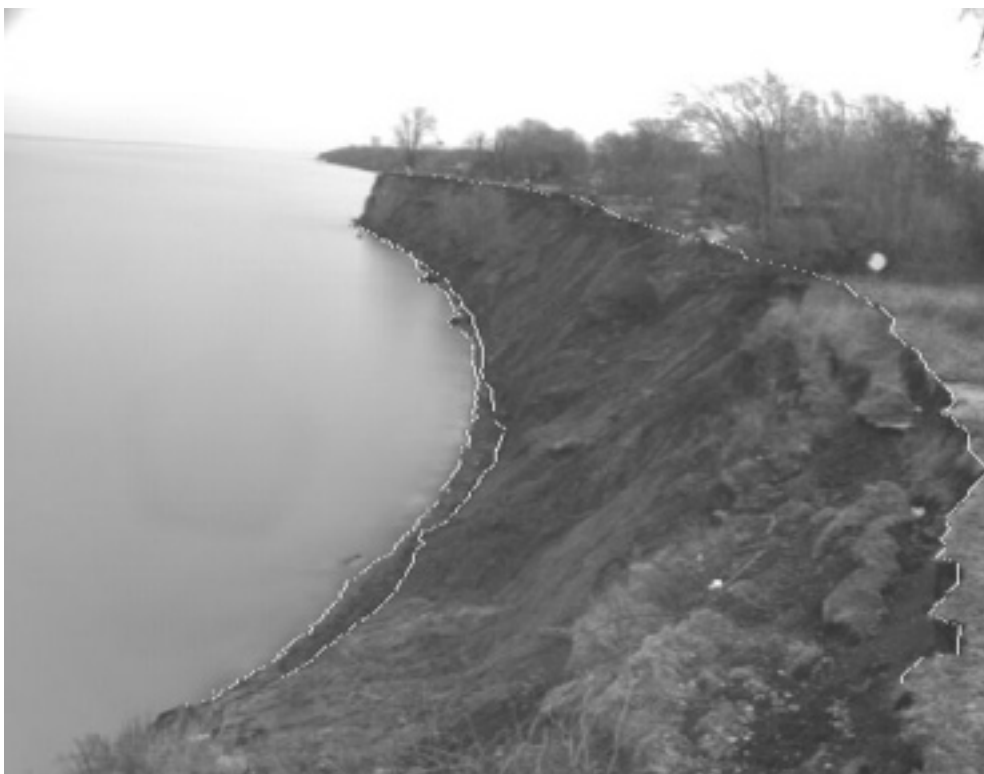
The above photographs are examples of remote video monitoring of the shorelines you have examined in this activity. Investigate more images of Lake Erie and at other sites by exploring the Internet address <http://stimpv.er.usgs.gov>.
